MODIFICATION WORK ORDER

MODIFICATION OF M93 PALADIN MUZZLE VELOCITY SYSTEM (NSN 1290-01-412-5759) (EIC: 3TC)

HEADQUARTERS, DEPARTMENT OF THE ARMY, WASHINGTON D.C.

15 December 2005

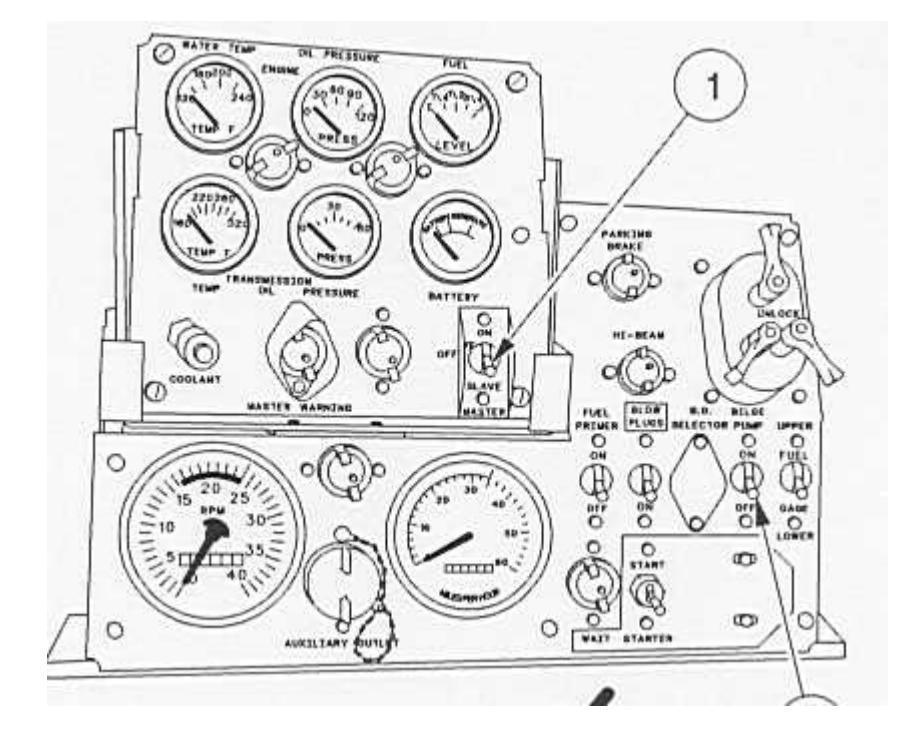
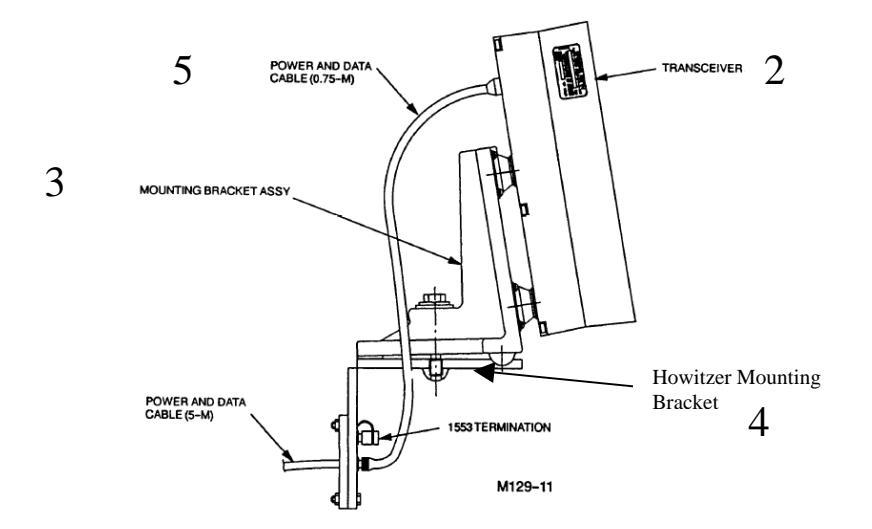
FIGURE 1

c. <u>PROCEDURES FOR REMOVAL</u>: The M93 Paladin Muzzle Velocity System must be removed from the howitzer in accordance with the following steps and figure 1:

- (1) Ensure that the vehicle MASTER switch (1) is in the **OFF** position.
- (2) Disconnect W92 power and data cable (5) from M93 radar antenna transceiver (2).

(3) Remove antenna-mounting bracket (3) from howitzer mounting bracket (4) by unscrewing the hex head mounting bolt (fig. 3, item 1) securing the two brackets together.

f. INSTALLATION: Install the transceiver and mounting bracket to the howitzer in accordance with the following steps and figure 1.

(1) Ensure that the vehicle **MASTER** switch (1) is in the **OFF** position.

(2) Position antenna-mounting bracket (3) on howitzer bracket (4).

(4) Install mounting bracket with attached transceiver to the howitzer's bracket and torque main bolt to between 450 and 500 in-lb (37.5-41.67 ft-lb).

(5) Connect W92 power and data cable (Fig. 1, Item 5) to M93 (upgraded) transceiver (Fig. 1, item 2).

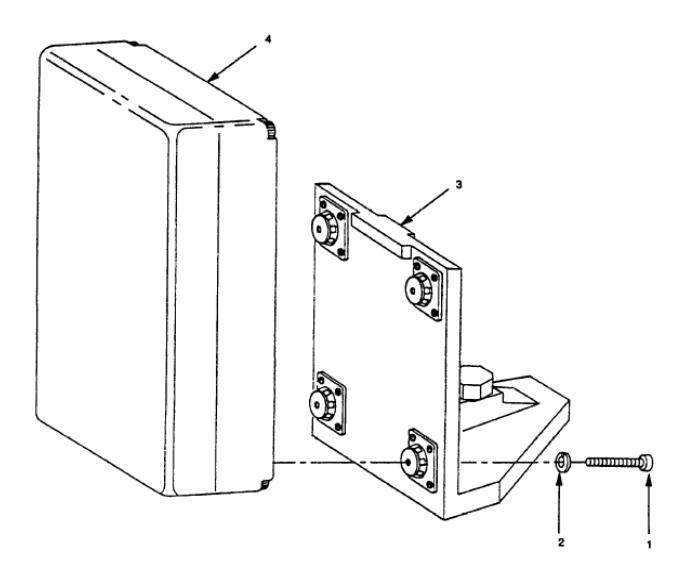
Figure 2

(1) Transceiver from antenna-mounting bracket. Remove the following parts in accordance with the following steps and figure 2:

(a) Unscrew and remove four screws (1) and four lock washers (2) that secure transceiver (4) to bracket assembly (3). See paragraph 8d regarding disposition of hardware.

(b) Remove and set aside for disposition per paragraph 8d, the transceiver (4) from bracket assembly (3).

(2) Transceiver to antenna-mounting bracket. Install the following parts in accordance with the following steps and figure 2:

(a) Correctly position transceiver (4) on bracket (3).

(b) Install four new screws (1) and four new lock washers (2).

(c) Using a hex head torque wrench (table 5), tighten each mounting bolt to between 60 and 70 in-lb (5.00-5.83 ft-lb).

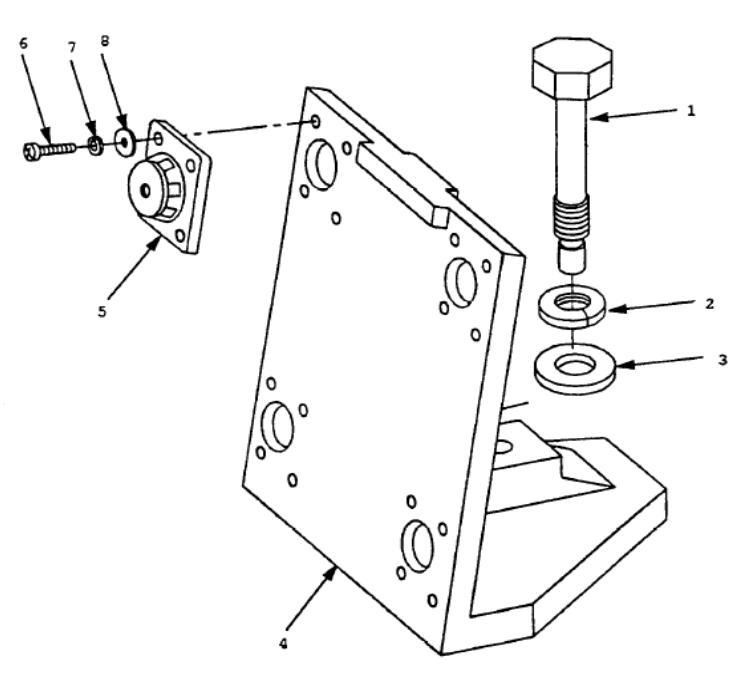
Figure 3

(2) Resilient mounts from antenna-mounting bracket. Remove the following parts in accordance with the following steps and figure 3:

(a) Unscrew and remove 16 screws (6), 16 lock washers (7), and 16 flat washers (8) from four resilient mounts (5).

(b) Remove and set aside for disposition per paragraph 8d, four resilient mounts (5) from bracket (4).

(1) Resilient mounts to antenna-mounting bracket. Install the following parts in accordance with the following steps and figure 3:

(a) Install four new (blue) resilient mounts (5) in the place of the four removed during disassembly.

NOTE: Blue resilient mounts must be installed with the hex nut visible from the backside of bracket.

(b) Insert and tighten 16 new screws (6), 16 new lock washers (7) and 16 new flat washers (8).

(c) Using a cross-tip torque wrench (table 5), tighten the mounting screws to between 20 and 25 in-lb (1.66-2.08 ft-lb).
