**TECHNICAL MANUAL  
MAINTENANCE INSTRUCTIONS  
DIRECT SUPPORT AND GENERAL SUPPORT MAINTENANCE  
M1078 SERIES, 2 1/2-TON, 4 X 4,  
LIGHT MEDIUM TACTICAL VEHICLES (LMTV)**

**VOLUME NO. 1 OF 2**

**HEADQUARTERS, DEPARTMENTS OF THE ARMY AND THE AIR FORCE**

**JUNE 1998**

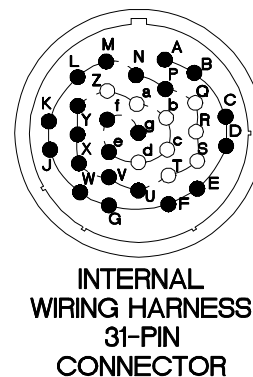
YBC2904B

- (1) Set multimeter to ohms.
- (2) Connect positive (+) probe of multimeter to internal wiring harness 31-pin connector pin L.
- (3) Connect negative (-) probe of multimeter to internal wiring harness connector G pin B and note reading on multimeter.
- (4) If continuity is not present, replace transmission internal wiring harness (para 7-13).
- (5) Connect positive (+) probe of multimeter to internal wiring harness 31-pin connector pin L.
- (6) Connect negative (-) probe of multimeter to all other pins in internal wiring harness 31-pin connector and note reading on multimeter.
- (7) Connect negative (-) probe of multimeter to ground and note reading on multimeter.
- (8) If continuity is present, transmission internal wiring harness is shorted; replace transmission internal wiring harness (para 7-13).
